Trim elements to roof/shell tool has issues.

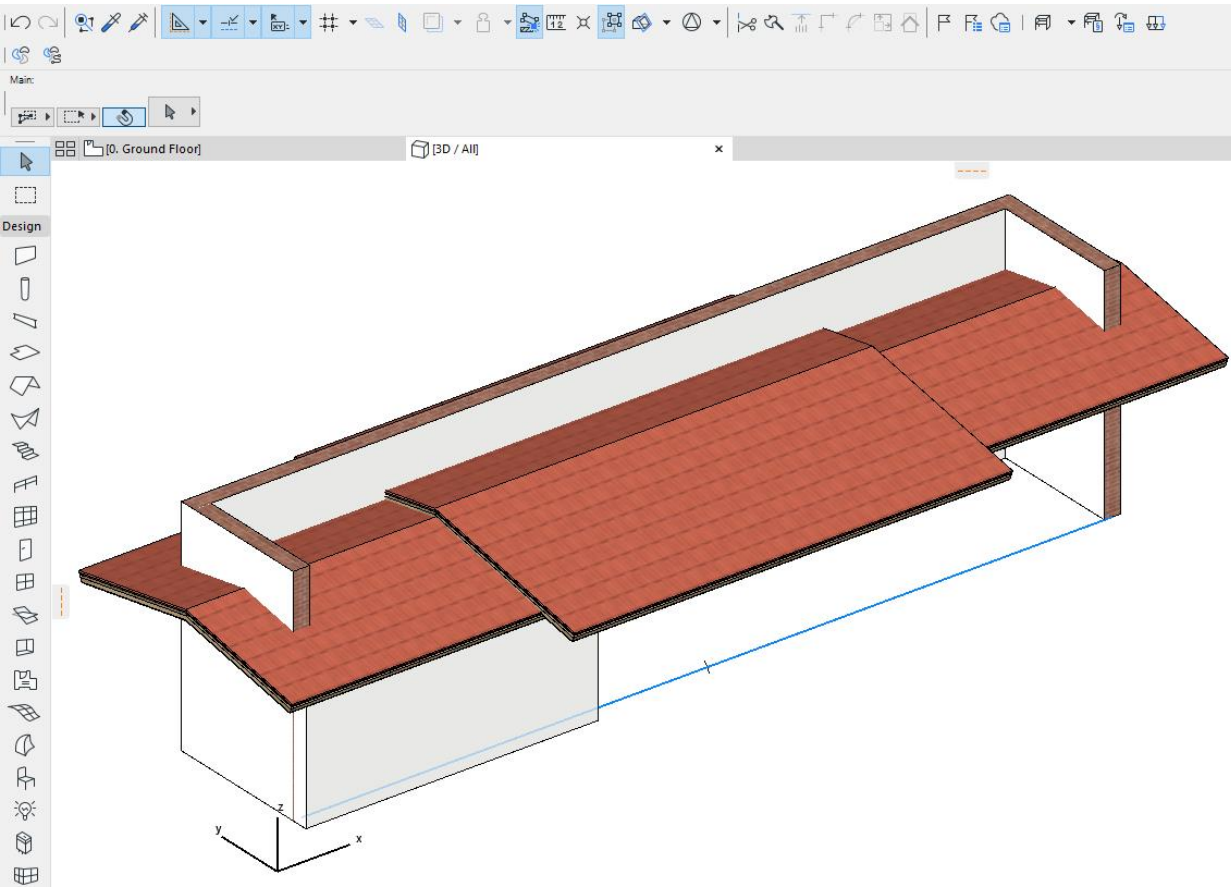
3D View

As highlighted below, wall continuing beyond roof boundary is no longer visible in 3D view, but the same wall is still visible as original condition in Plan. This generates incorrect graphics representation, if wall is not visible in plan then should also be visible in 3D view without trim condition for area beyond roof boundary.
